**Antelope Guzzler Report**
**Hatch Guzzlers Maintenance Report 2012**

***Summary of Maintenance and Repair Needs***

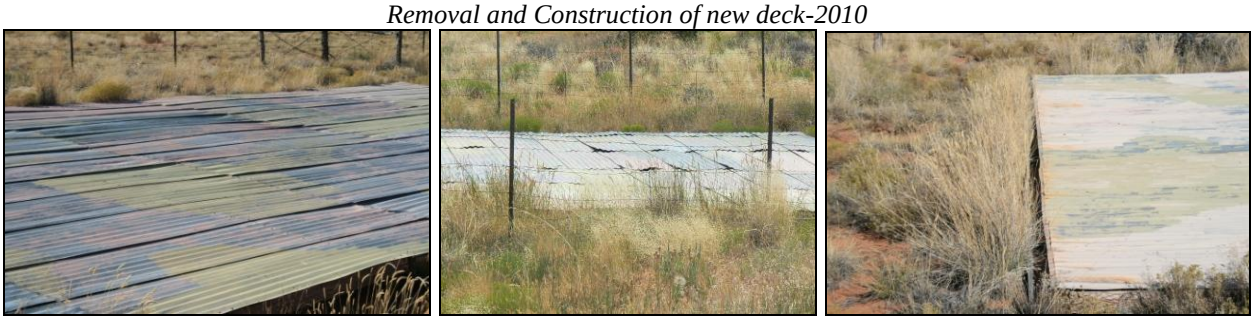
*Removal and Construction of new deck-2010*

*Old Deck-2009*

***2011-*** *Inspected in the spring, in working order, water turned on and turned off in the fall before the cattle came on.*
***2010****- Drinker, valves & catchment replaced. New plumbing and values were installed and system is back on line. New drinker and new valve box have been installed. New 42' X 24' catchment surface and base installed and gutter repaired. Storage tank has water.*
